Owner: City of Vancouver
Location: North main pier, Granville Street Bridge, Vancouver, British Columbia
Coordinates: 49°16'23"N, 123°07'56"W
Market: Structural Rehabilitation
Start / Completion Dates: July 2011 – December 2011
Contract Value: CDN \$377,000

**Project Description:**

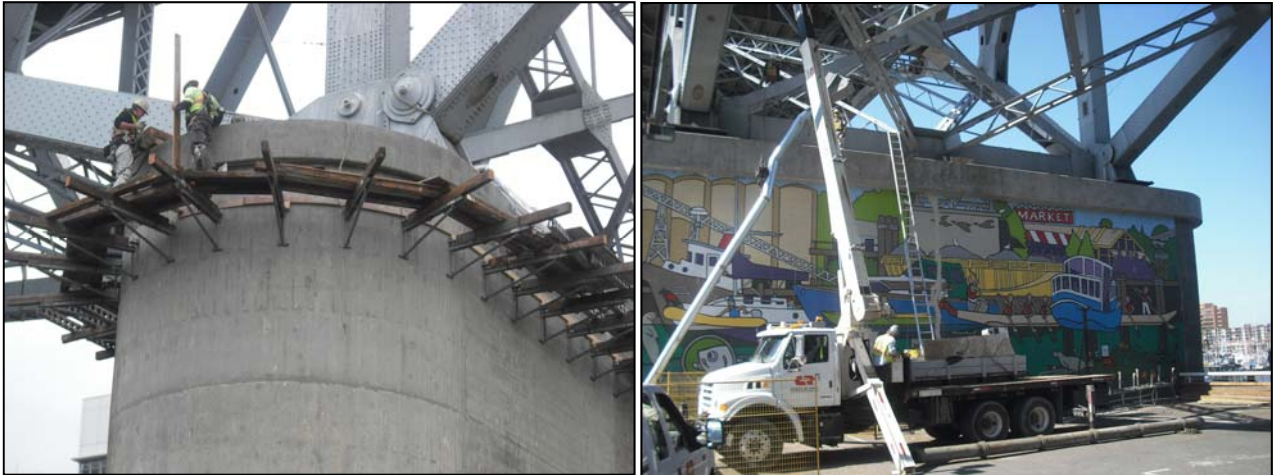
The aging Granville Street Bridge, built in the early 1950's, has undergone numerous upgrades and life-extension works over the past decade. Recently, it was discovered that a large vertical crack had developed in the north main-span pier.

To restore the integrity of the pier, a reinforced, post-tensioned, ring beam was designed to encase the top of the pier, just below the main bearings. Through the installation of injection ports, the crack itself was completely filled with high-strength epoxy resin.

As General Contractor, Coquitlam Ridge Constructors completed all preparatory works, access installation, and construction of the concrete ring-beam. Epoxy injection and post-tensioning works were completed by local subcontractors.
