Twin Falls Pedestrian Bridge Repairs

Owner: District of North Vancouver
Location: Lynn Canyon Park, North Vancouver, British Columbia
Coordinates: 49°06'11"N, 122°04'39"W
Market: Structural Repairs
Start / Completion Dates: April 2009 – May 2009
Contract Value: CDN \$46,200

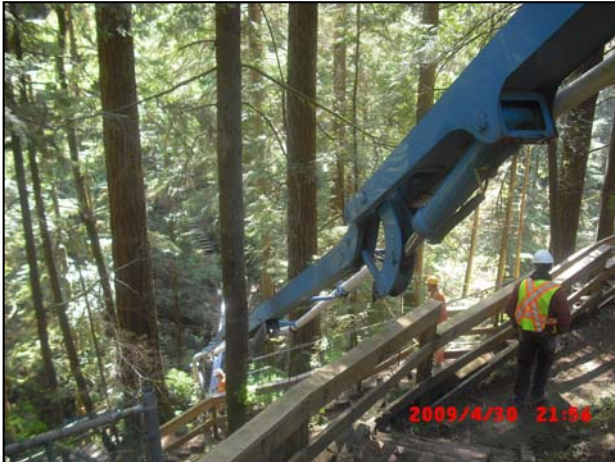
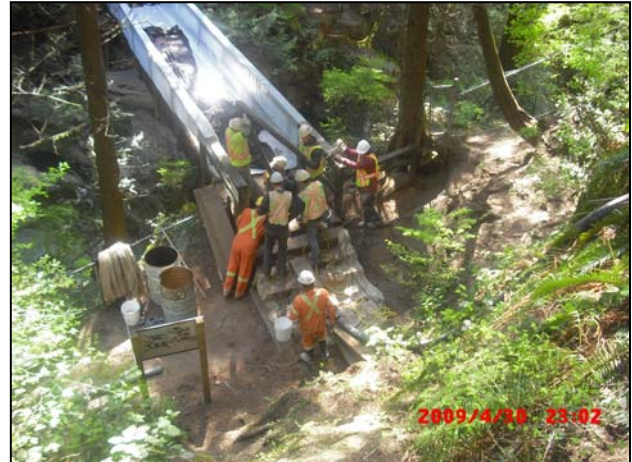
Situated in dense damp forest, the completely timber bridge had a number of rotten members which were repaired. Additionally, a mid-span pier was constructed atop of a rock outcropping to provide additional capacity to the main beams.

On-site work included rock-drilling, anchor installation, forming and casting of pier-footing and abutment concrete, and installation of large timber components.
