**Owner:** BC Ministry of Transportation and Infrastructure  
**Location:** Morris Valley Road Crossing of Chehalis River, Harrison Mills, British Columbia  
**Coordinates:** 49°17'56"N, 121°56'08"W  
**Market:** Structural Repairs  
**Start / Completion Dates:** December 2009 – May 2010  
**Contract Value:** CDN \$571,000

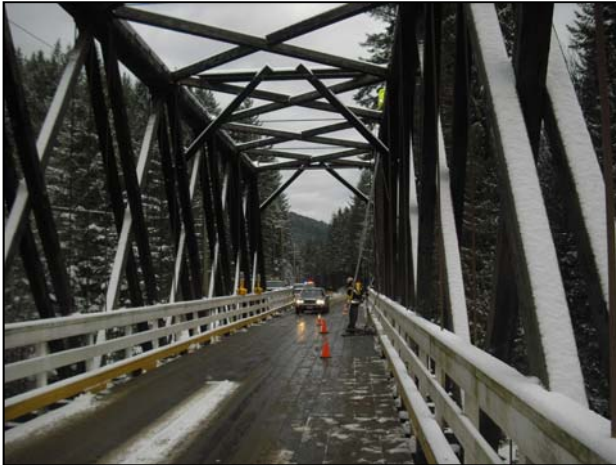
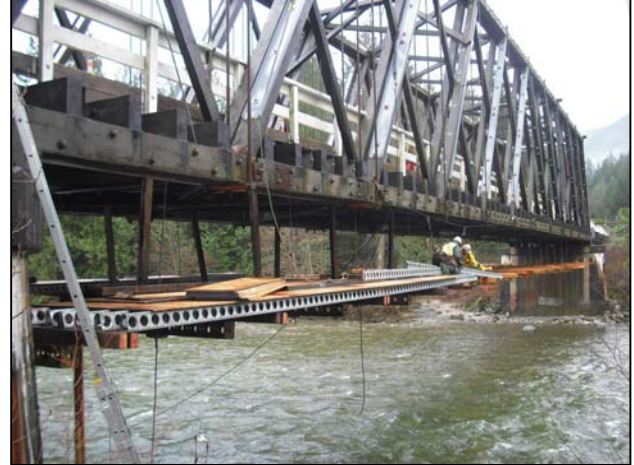
Following the failure of a diagonal timber member, the only crossing of the Chehalis River was closed to traffic. An immediate emergency stabilization was required to allow local residents access across the river.

Following the stabilization of the bridge, a steel replacement diagonal member was installed, along with a number of additional steel components to ensure that the aging timber truss remains in service until its ultimate replacement.

Following the initial stabilization, CRC was tasked to complete the installation of an access platform, allowing for the installation of bottom-chord tensioning system as well as add steel channel reinforcement to a number of timber truss components. These upgrades ensure the required load-carrying capacity of the structure can be maintained.
